SURVEY OF CONDITION

of
The Stone Barn,
Hall Road, Bramley,
Surrey GU5 0AX

**St Catherine's School,
Bramley, Surrey
GU5 0DF**

28 September 2017

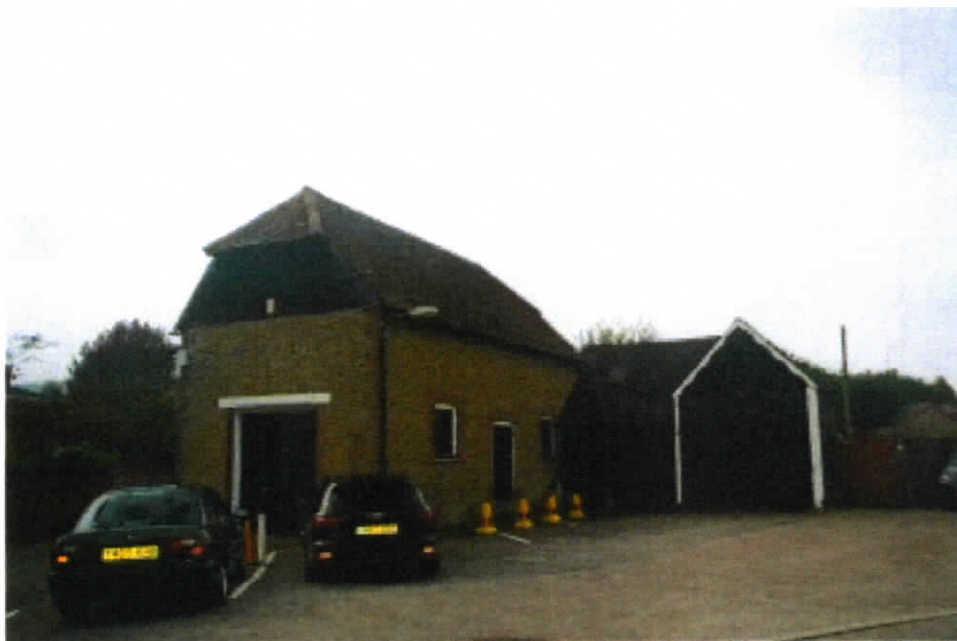
The property is a stone barn probably built in the 18th century. It has a tile covered roof.

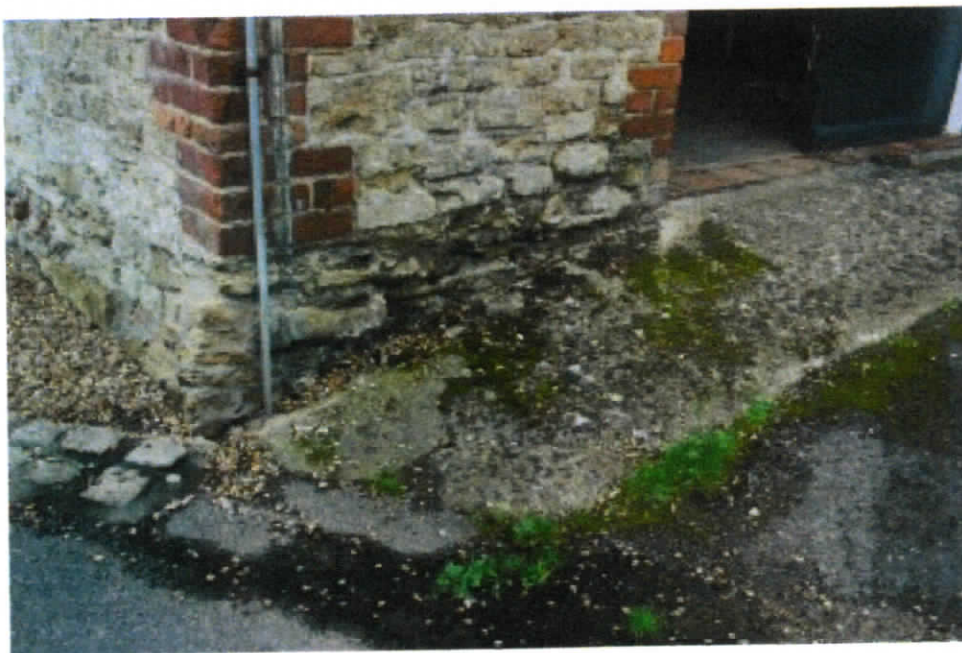
The ground level on the South side has been reduced over the years. The foundations on this side are therefore probably very shallow.

There are no signs of recent movement, and as these cracks have developed during the last two hundred years or so, they are not considered to be the result of recent movement and therefore do not require any immediate action. However, it would be prudent to restore the ground level on the South side to its original height. In particular, this would reduce the amount that is washed away by passing traffic.

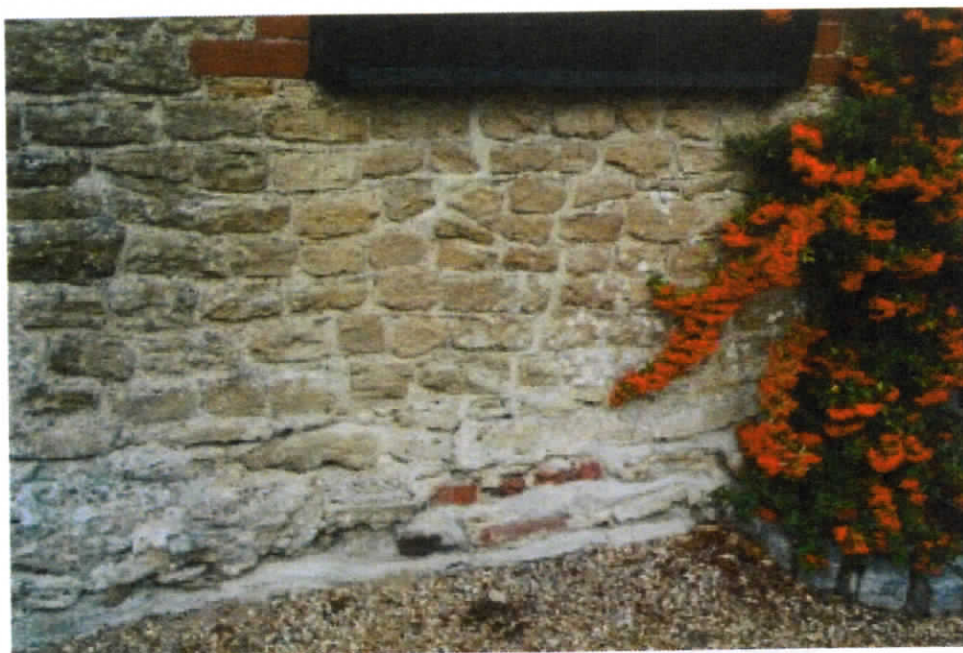
There are signs of some recent mortar work at low levels in the walls, indicating that this problem has been recognised in the past.

The central part of the South wall is out of plumb by only a small degree. This will be referred to again later.

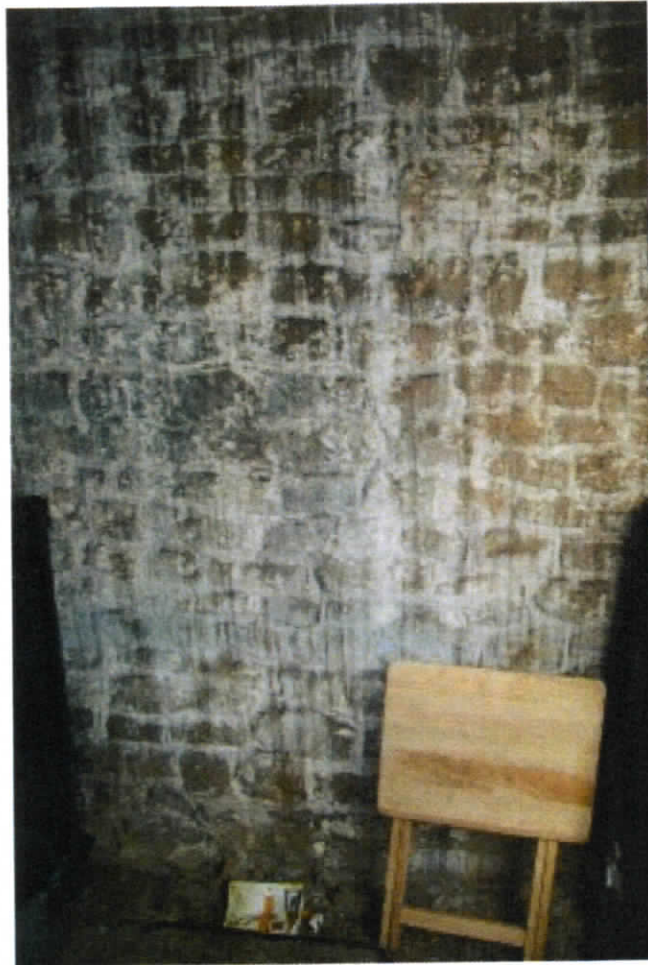
There are many random cracks to the external surface. Some appear to have been repointed twenty or thirty years ago and leave only hairline cracks with the new mortar. Elsewhere, there are irregular cracks of 2-3mm in width.

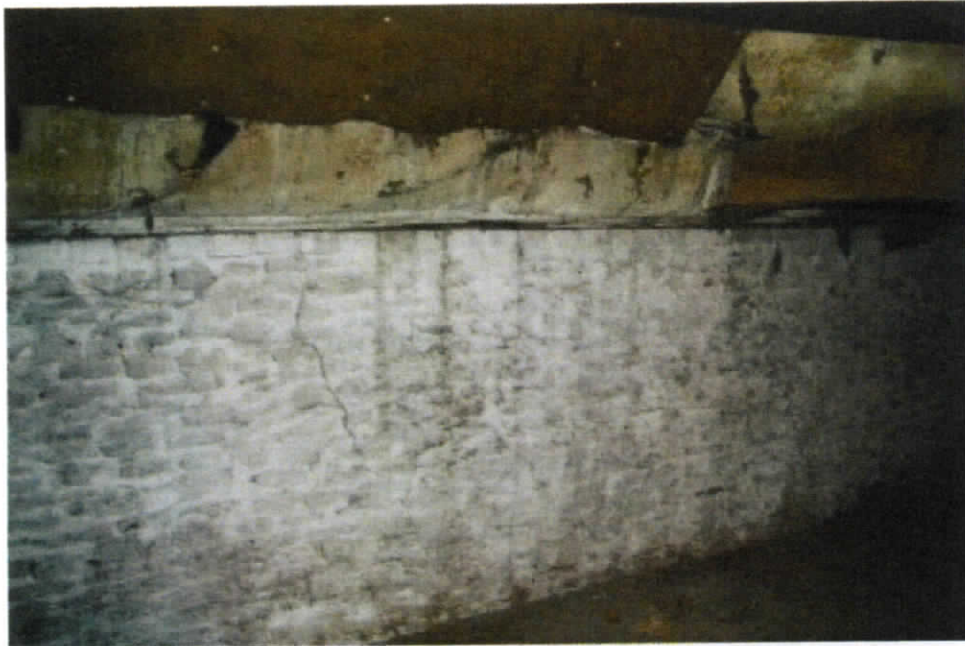
The cracks are mostly associated with the South wall rotating outwards at the top. This has had the effect of pulling parts of the inner leaf of the North wall over due to the tie beams which span the building.

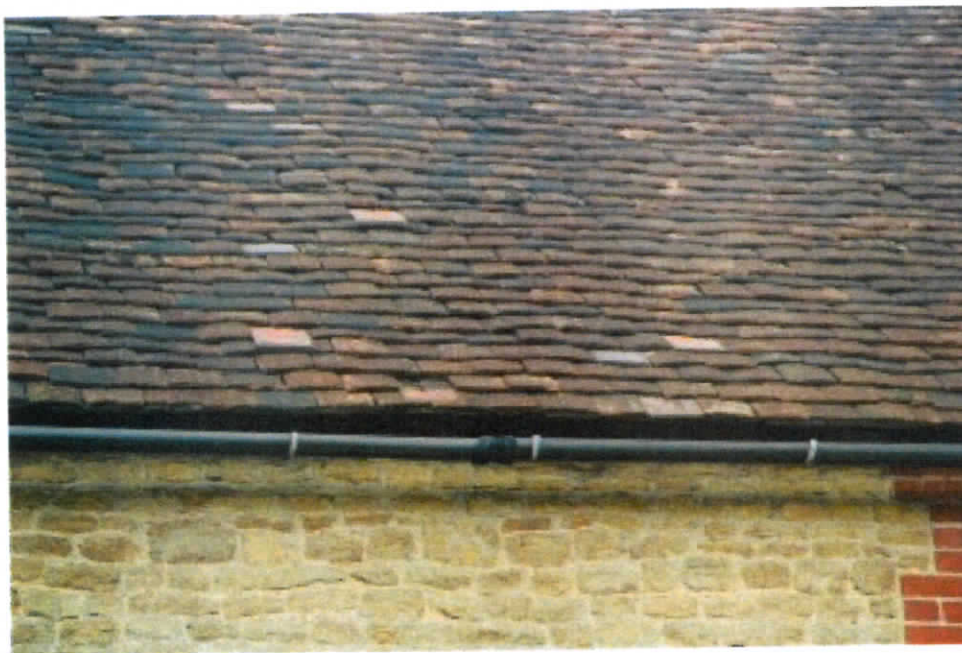
The roof is covered with handmade clay tiles. They are typically uneven in appearance. There are signs that many have been replaced over the years.

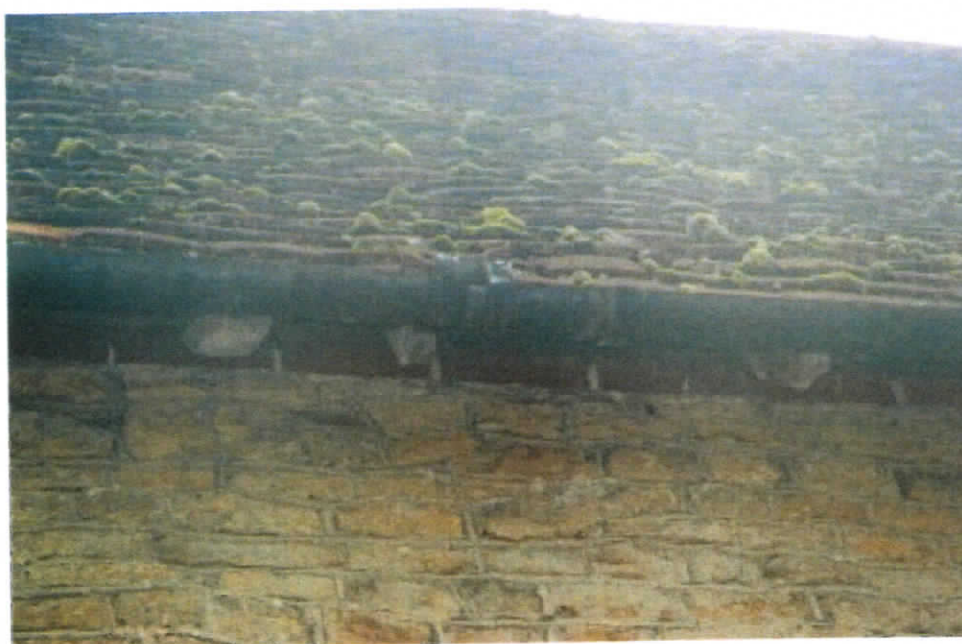
The tiles sag at the eaves. This is presumably due to the tilting battens having rotted. Some repairs are necessary.

There is some work necessary to the edges of the roof, but overall it is in fair condition for the time being.

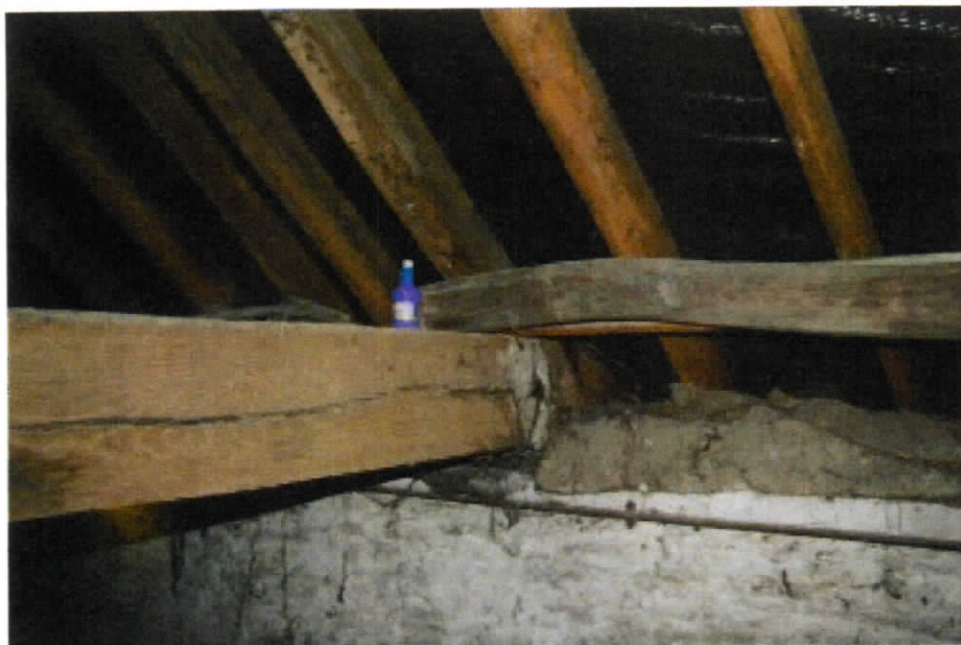
Under the tiles there is reinforced roofing felt. It is of bitumen with a fabric strengthening. It is possible that the fibres could contain asbestos but in this situation they are considered a very low risk.

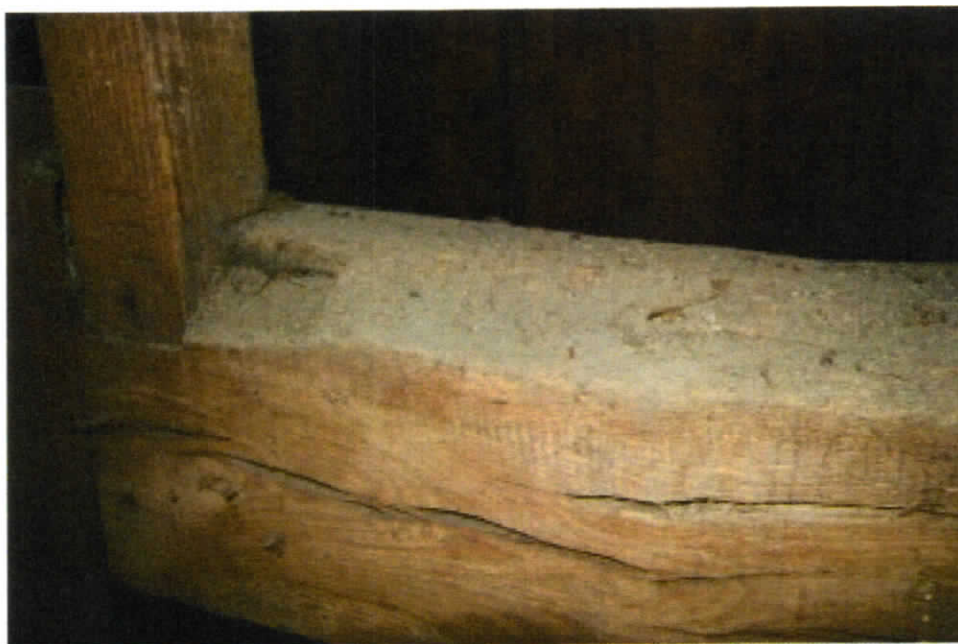
The roof has an ancient timber frame with major tie beams at eaves level. On these are posts supporting tie beams and purlins. The timbers show signs of infestation by wood-borers, but no recent activity was observed.

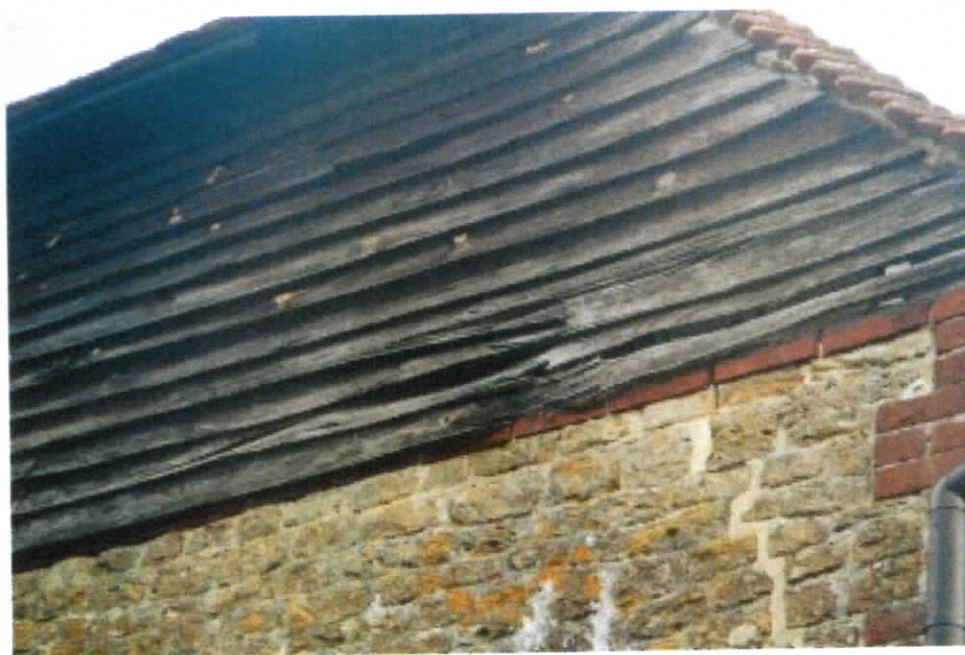
At the North and South ends, there are semi-gables with weatherboard outside. The weatherboard is rotting and some replacement is necessary.

These parts are lined internally with some ancient form of lining paper or fabric which has rotted. You will want to clear it away.

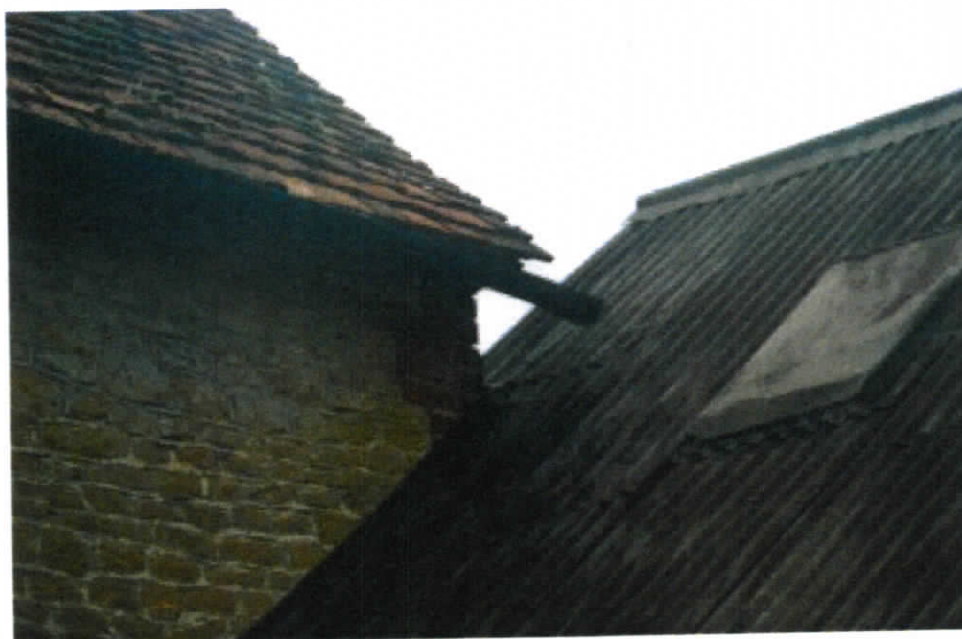
There are half-round black uPVC rainwater gutters with matching downpipes. On the North side at the West end, the gutter is hanging away and water is discharged onto the roof of the neighbouring building.

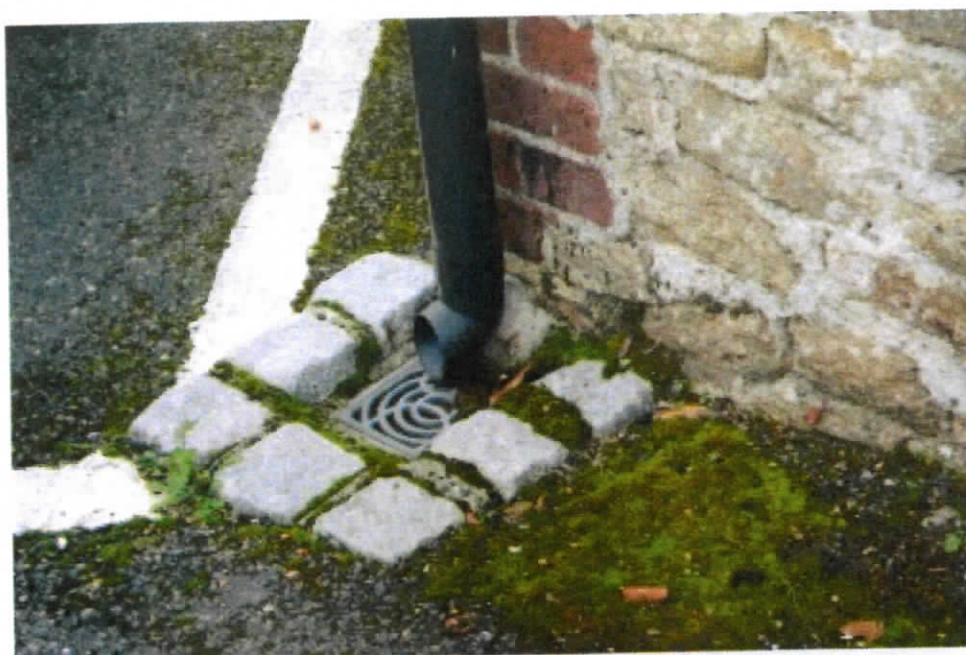
On the East end of the North side, the downpipe discharges over a gulley. It is assumed that this runs to a soakaway.

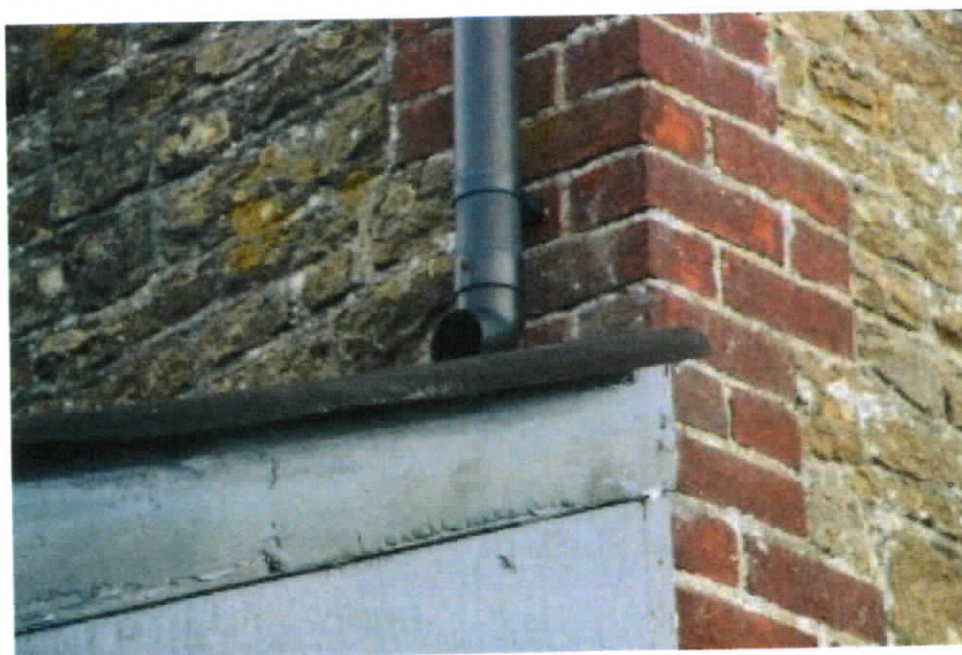
On the South side, the rainwater gutter runs the full length of the building and is conducted via a downpipe to discharge onto the roof of the neighbouring lean-to building.

The right to discharge water onto the adjoining property is presumably well established. Your solicitor should advise.

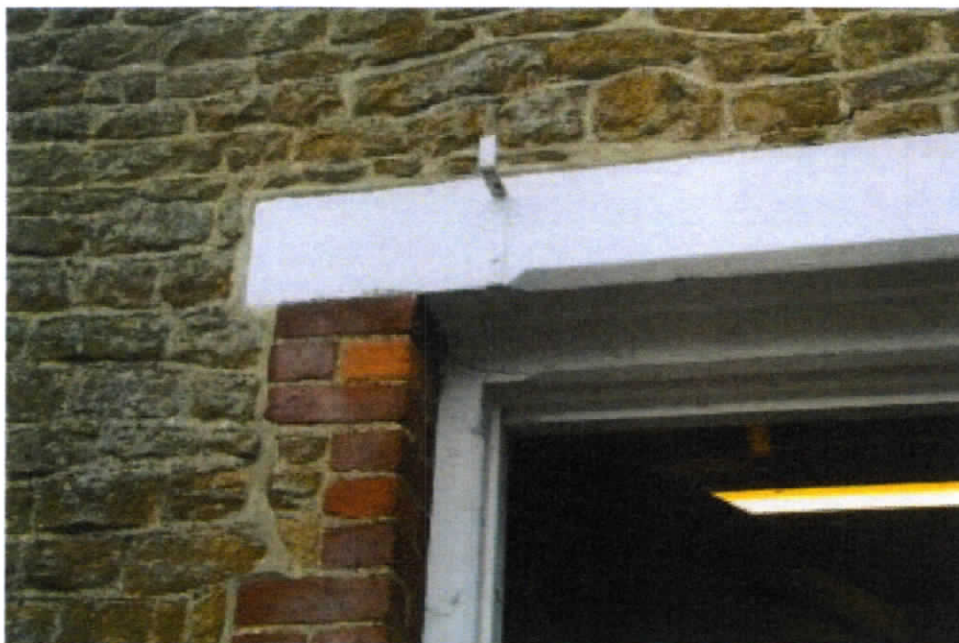
The principal entrance has a pair of painted softwood doors. They are old and distorted. They are strengthened internally with a diagonal length of angle iron. They remain serviceable but are not in good condition.

Above the doors is an ancient timber lintel. It is painted. As far as could be seen, it appears to be in good condition.

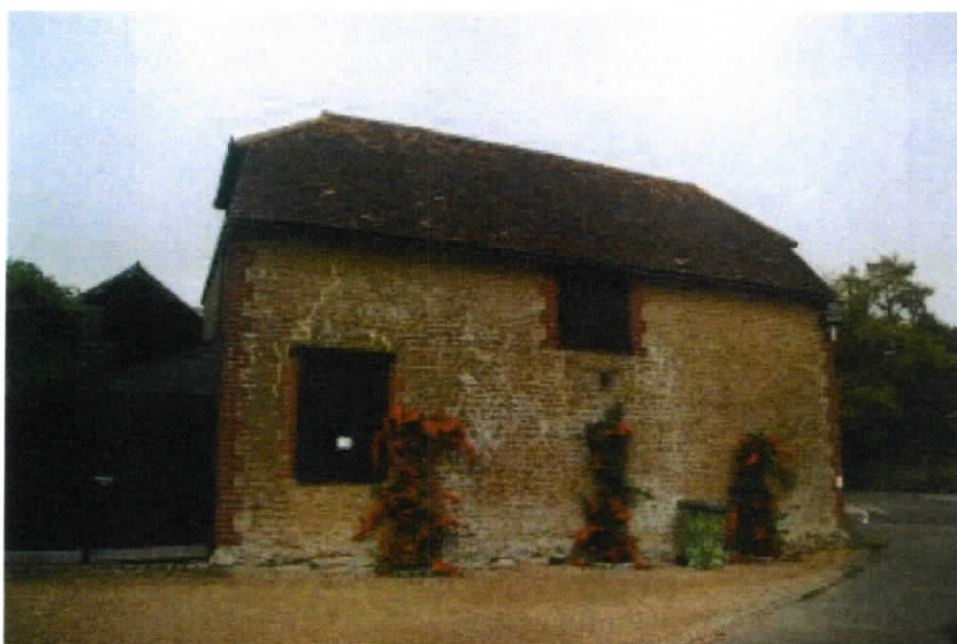
There are a number of ancient openings in the walls. These are fitted with panelling or opening hatches. They serve their purpose.

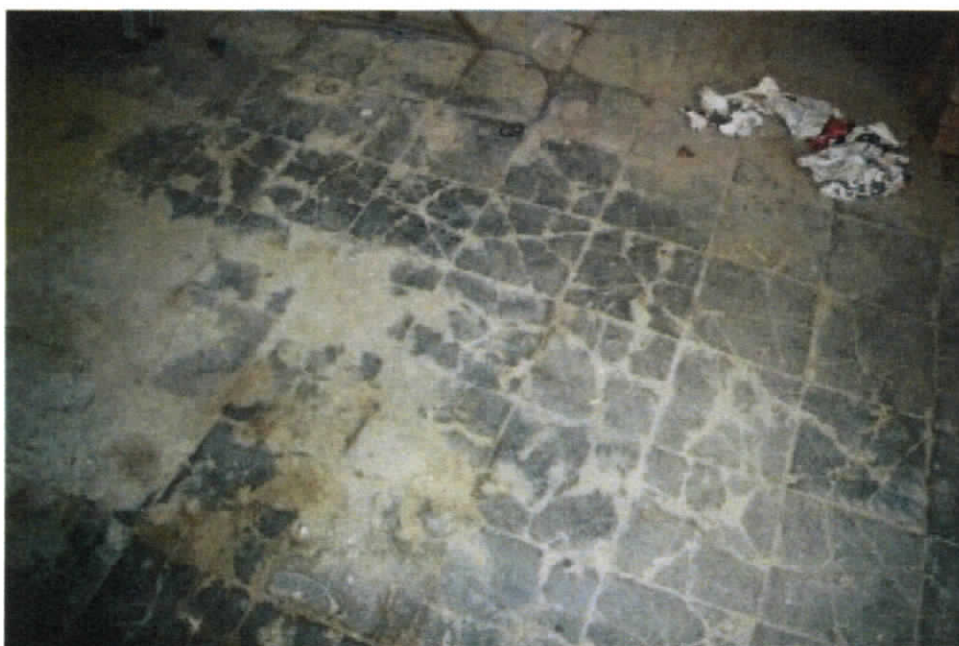
The ground floor is of solid construction. It is covered with black quarry tiles. It is dirty and damaged and damp. Nonetheless, it remains serviceable for its present purpose.

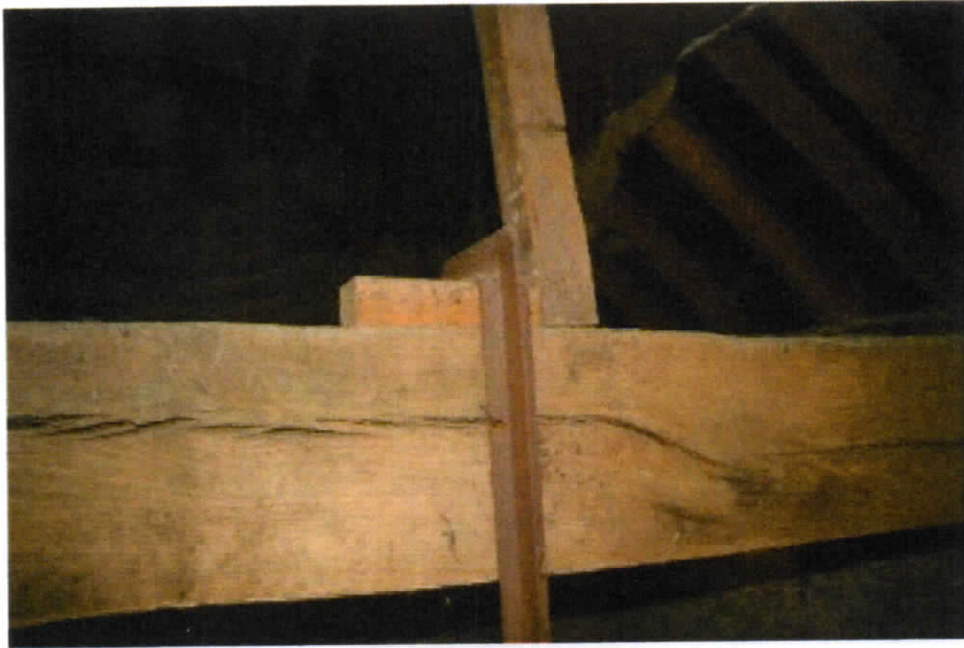
The first floors are supported by angle iron hangers which have been presumably made by a blacksmith to hook over the tie beams and under timbers supporting the first floor. These have surface rust but otherwise appear to suit their purpose.

If it is thought desirable to create a proper first floor, it will be necessary for modern engineering calculations to be made to establish whether the tie beams are sufficient to support a floor on the angle iron hangers, or whether a new structure supported on the external walls should be constructed.

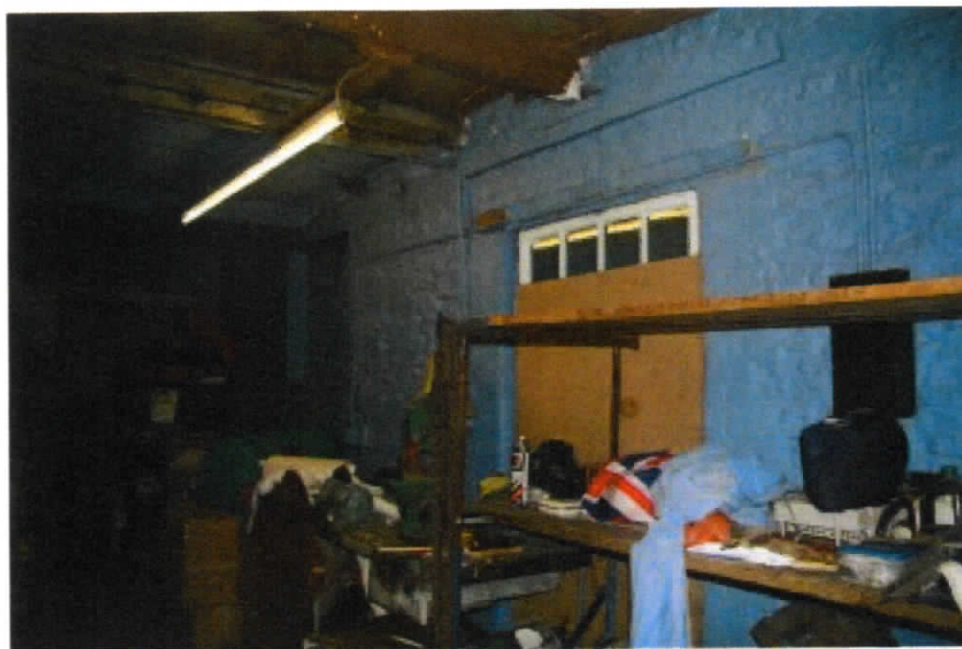
At present there are 200mm x 75mm beams spanning the barn which support the loose timbers which serve as a floor. There are also hardwood beams set diagonally in the walls in the style of the 18th century. These in part support the floor at the West end.

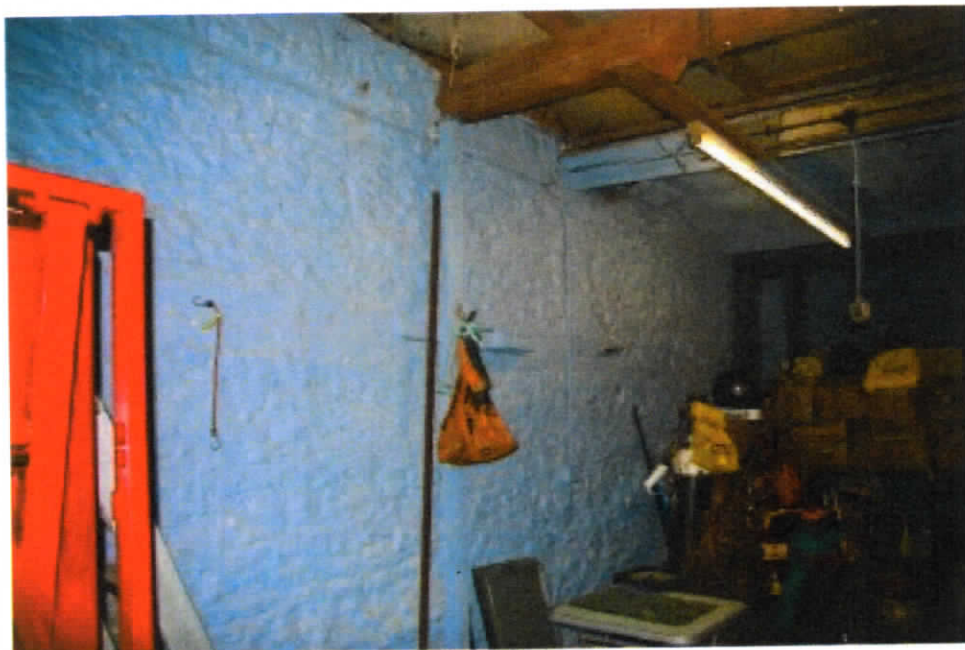
Most of the internal surfaces at ground floor level have been painted. The paint is old and worn. If you wish to repaint the interior, thought should be given to the quality of paint to be used on the stonework.

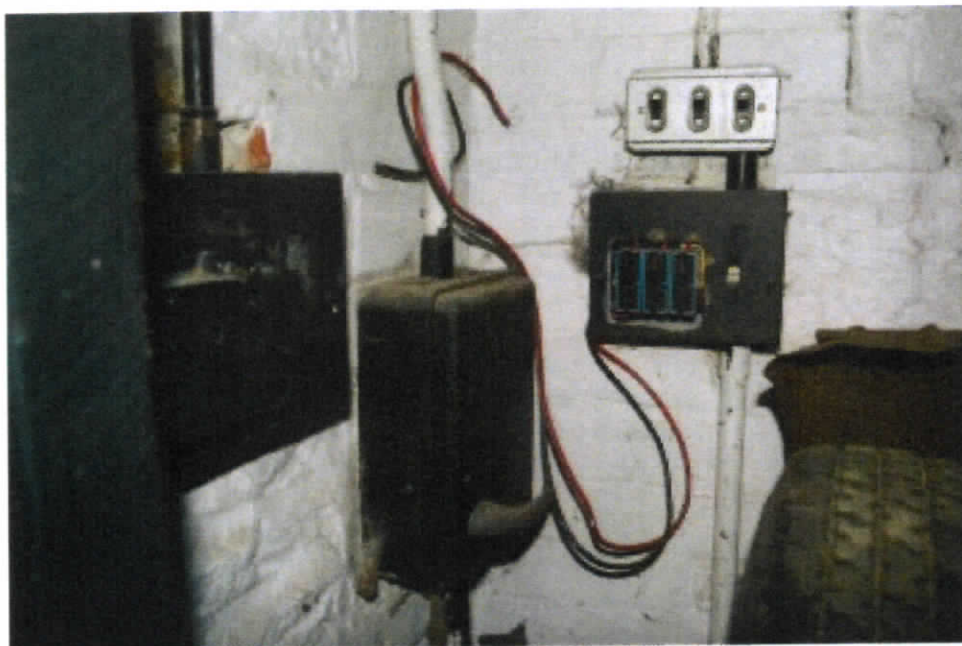
There is an electric meter and an old cast iron box containing the main switch in the South East corner. There are a number of other old fuse boxes and switches in that corner. Elsewhere in the barn, there are metal conduits containing electric wiring. There are various light and power points.

The whole of the electrical installation is substandard and it will be necessary for you to rewire the building to your own requirements.
